Manhole Inspection Summary

Manhole # S31I2002MH

Location Address: **5917 CHARLESMEADE AVE**

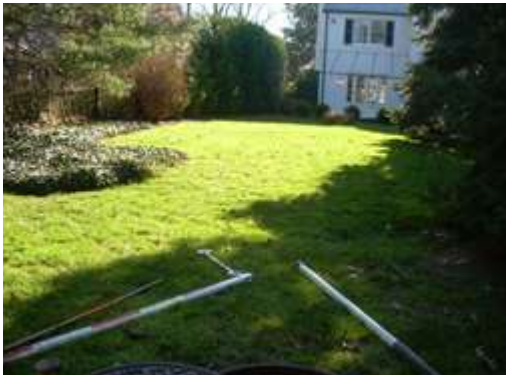
Location View

Comments **This MH is located on private property.**

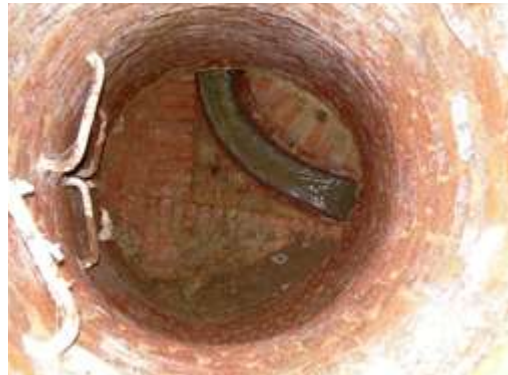
Top View

Evidence of surcharge - Bench debris.
Corroded steps.

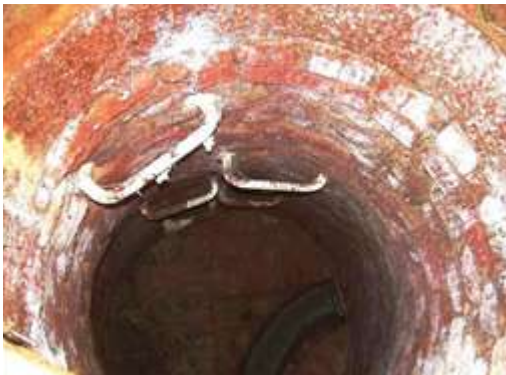
Defect

Adjustment, Corbel and Barrel infiltration -
other side.

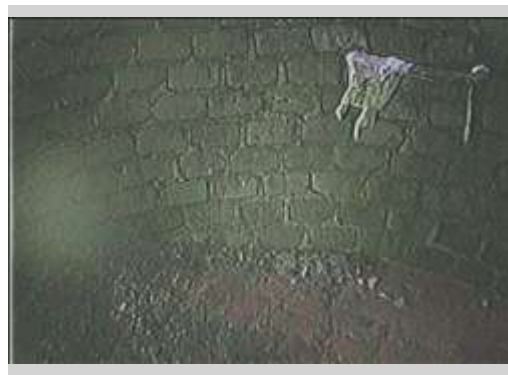
Defect

Condition: ☐ Sound ☐ Cracked ☐ Root Intrusion ☐ Loose Brick ☒ **Deteriorated**

Infiltration: ☐ None ☐ Joint ☐ Cracks ☒ **Mortar** ☐ Roots ☒ **Wall**

Barrel deterioration and infiltration.

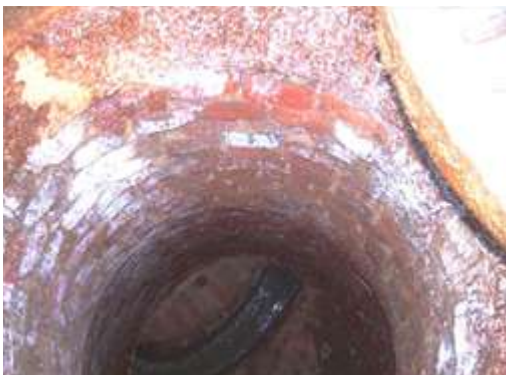
Defect

Infiltration: ☐ None ☒ **Joint** ☐ Cracks ☒ **Mortar** ☐ Roots ☐ Wall

Infiltration: ☐ None ☐ Joint ☐ Cracks ☒ **Mortar** ☐ Roots ☒ **Wall**

Adjustment, Corbel and Barrel infiltration.

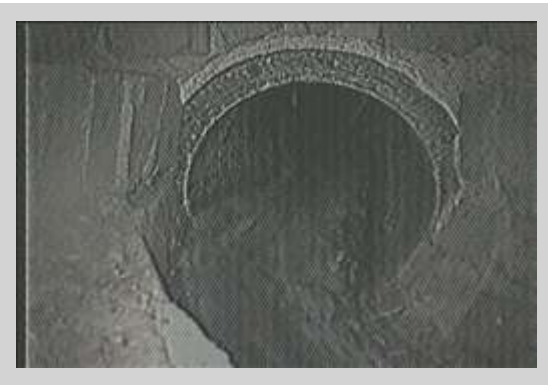
10 in. Circular Gravity Sewer Pipe Out @ 12 O'Clock

Channel deterioration.

Infiltration: **Evidence** Pipe Seal Cond: **Unknown**

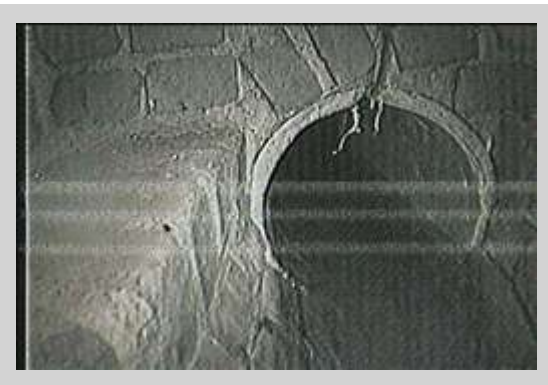
10 in. Circular Gravity Sewer Pipe In @ 4 O'Clock

Infiltration: **Evidence** Pipe Seal Cond: **Roots**
